Manhole Inspection Summary

Manhole # S45E__032MH

Insp Date: **7/23/08 8:47 AM**

Location Address: **1747 S Ann St**

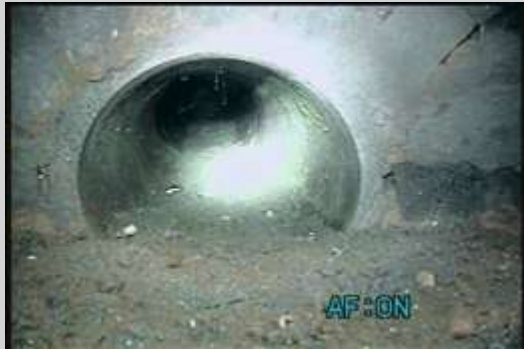
12 O'Clock Outflow

8 in. Circular Gravity Sewer
Pipe Out @ 12 O'Clock

Infiltration: **None** Pipe Seal Cond: **Unknown**
